Contra Costa County Grand Jury Report 0908
**Surrounded by Water, Bethel Island
Has Limited Access for Fighting Fires**
**Inadequate funding leaves ECCFPD communities
behind the rest of Contra Costa County in Fire Services**

**Contra Costa County Board of Supervisors
East Contra Costa Fire Protection District**

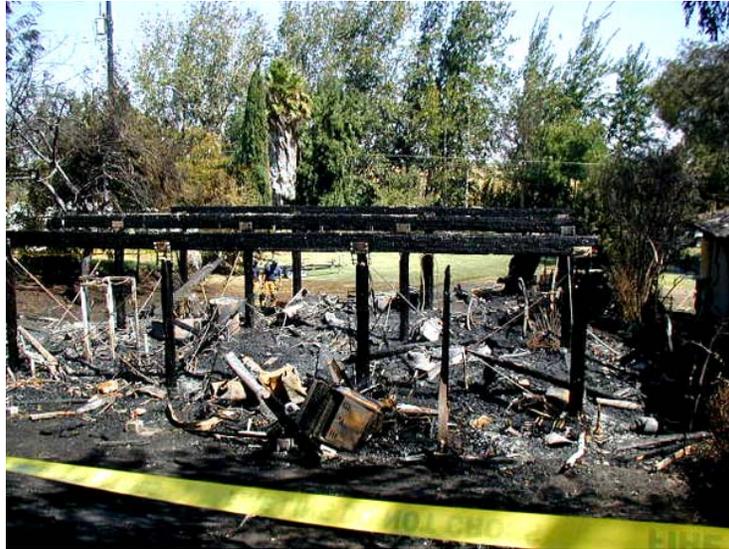
On September 8, 2008, 54 firefighters and 18 trucks battled a fire on Bethel Island. The fire involved the destruction of two houses located next to Taylor Slough levee. Immediate access to the levee was delayed due to confusion over the location of the keys that would provide vehicle access. A steel cable eventually had to be cut before equipment could be properly positioned to draft water from the Delta. The appropriate keys were subsequently located in one of the fire trucks. An image of one of the destroyed homes is shown on the next page. (Picture courtesy of Glenn Peck).

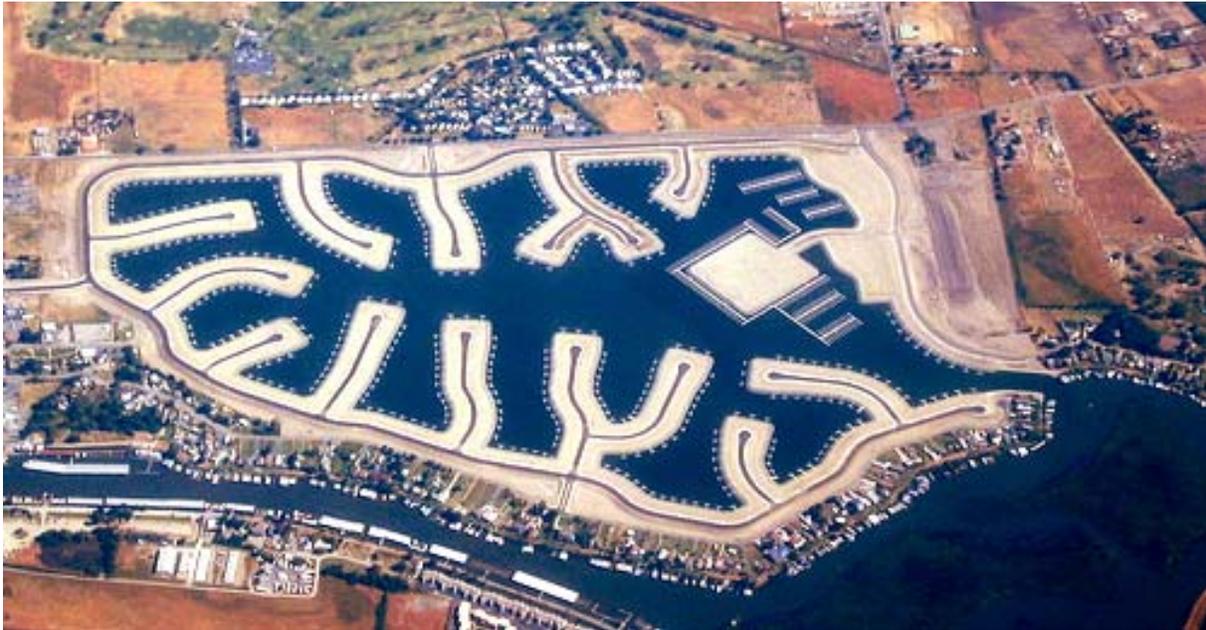
Delta Coves, a new sub-division, has completed most of its required infrastructure. Numerous economic issues have delayed the development of the project indefinitely. This new development could add approximately 500 new homes, 50 condominiums, a club house, a new fire house and other amenities. Although fire hydrants are in place, a source of water will have to be acquired prior to any further construction.

Delta Coves, a partially developed subdivision on Bethel Island without water to the fire hydrants

- strategic placement of water tanks, and/or
 - provide a method to move Delta water to the land side.
5. That the BOS work in cooperation with the Fire District to ensure that the objectives of ECCFPD are part of the decision making process as the Bethel Island Delta Coves project progresses.

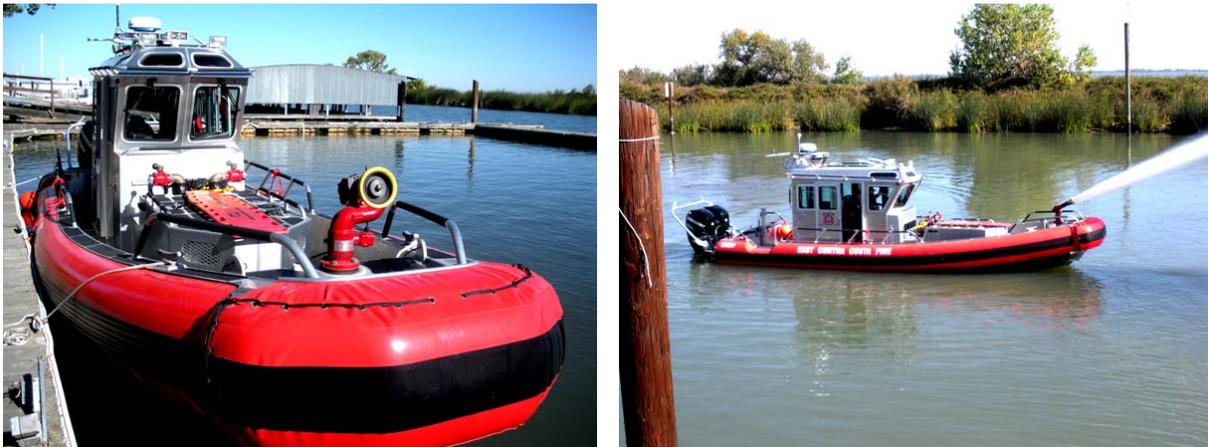
12. ECCFPD recently acquired a state-of-the-art fire boat, which uses a two to three-person crew. This boat is on call for all of Contra Costa County and surrounding waterways. Therefore, it may or may not be available at any given time because of its coverage area. If the boat is required to fight a fire, firefighters from one of the responding fire engines could board the boat at the scene to achieve the needed crew size.

A recently acquired state-of-the-art fire boat for use in Contra Costa County

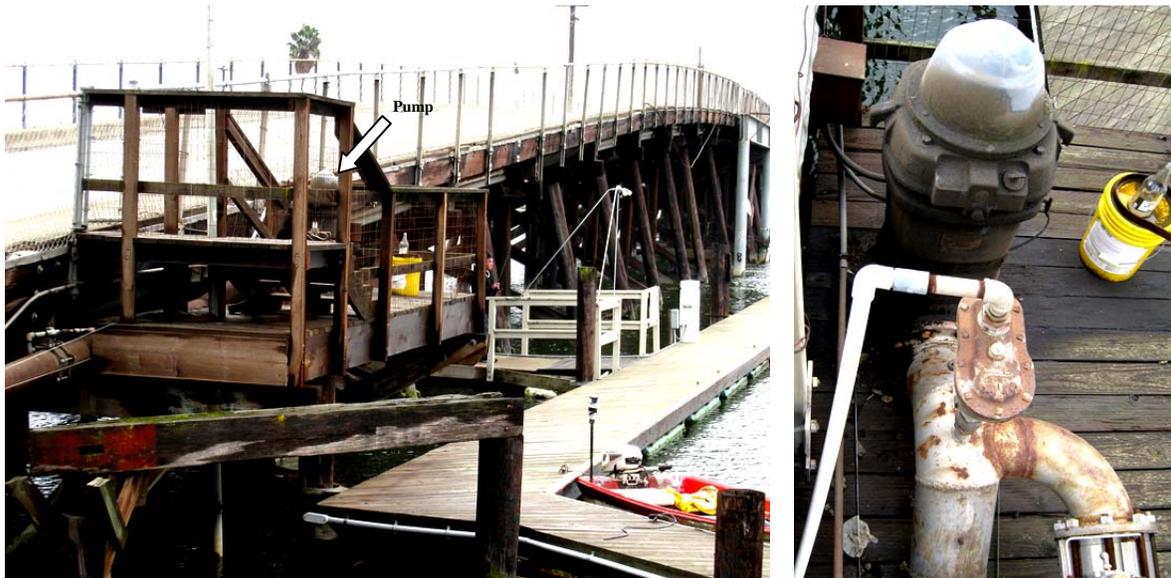
16. The system required to keep the water flowing to the business district hydrants failed in 2006 and has not been repaired or replaced. The pipes are old and in questionable condition. This pumping system, if operational, would provide water to service the business district. In addition to the 1,250 gallons of water available on the fire trucks, and local private working pumps, water to fight fires is brought in by tanker trucks or drafted (pumped) from the Delta. The Grand Jury was unable to determine the ownership of the pump and hydrants.

Abandoned Pump Intended for Fire Protection of Bethel Island's Business District

4. That ECCFPD develop a cost comparison of various options to provide additional water supply for fire use on Bethel Island. Suggestions include but are not limited to:

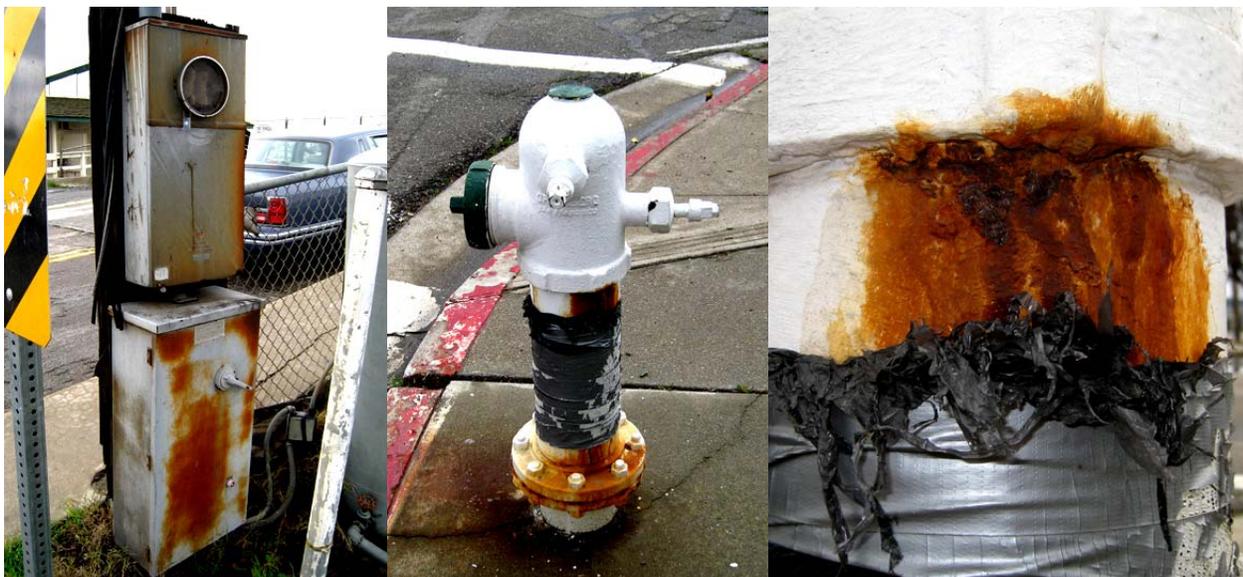
Abandoned switch meter box for pump, and an unused corroded fire hydrant in the business district

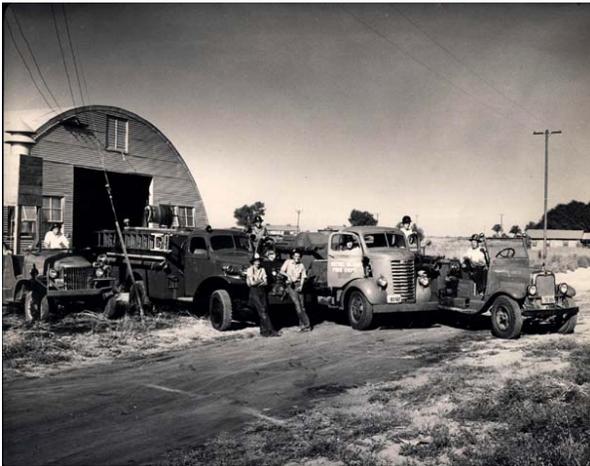
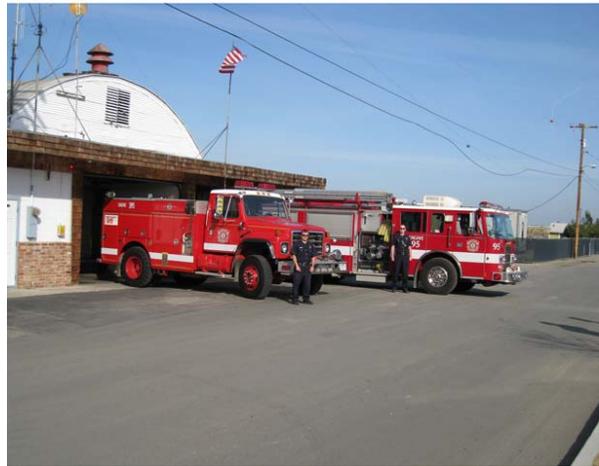
The Fire House photographed in the 1940s and in February 2009. This fire house has been condemned and will be replaced in the near future. The two trucks currently assigned to Bethel Island have water capacities of 500 and 750 gallons of water. If needed, additional water must be brought in by tanker trucks.

22. The fire station is uninhabitable due to the presence of mold. This requires the leasing of temporary facilities for the housing of personnel. Only firefighting equipment is permitted in the existing building. When permits are issued, it will be demolished.
